**EXAMINATION OF FAILED SIX INCH
CAST IRON PIPE NATURAL GAS
MAIN, BROOKLYN UNION GAS
COMPANY, QUEENS COUNTY,
NEW YORK**

Bruce W. Christ and T. Robert Shives

Failure Analysis Report

July 1976

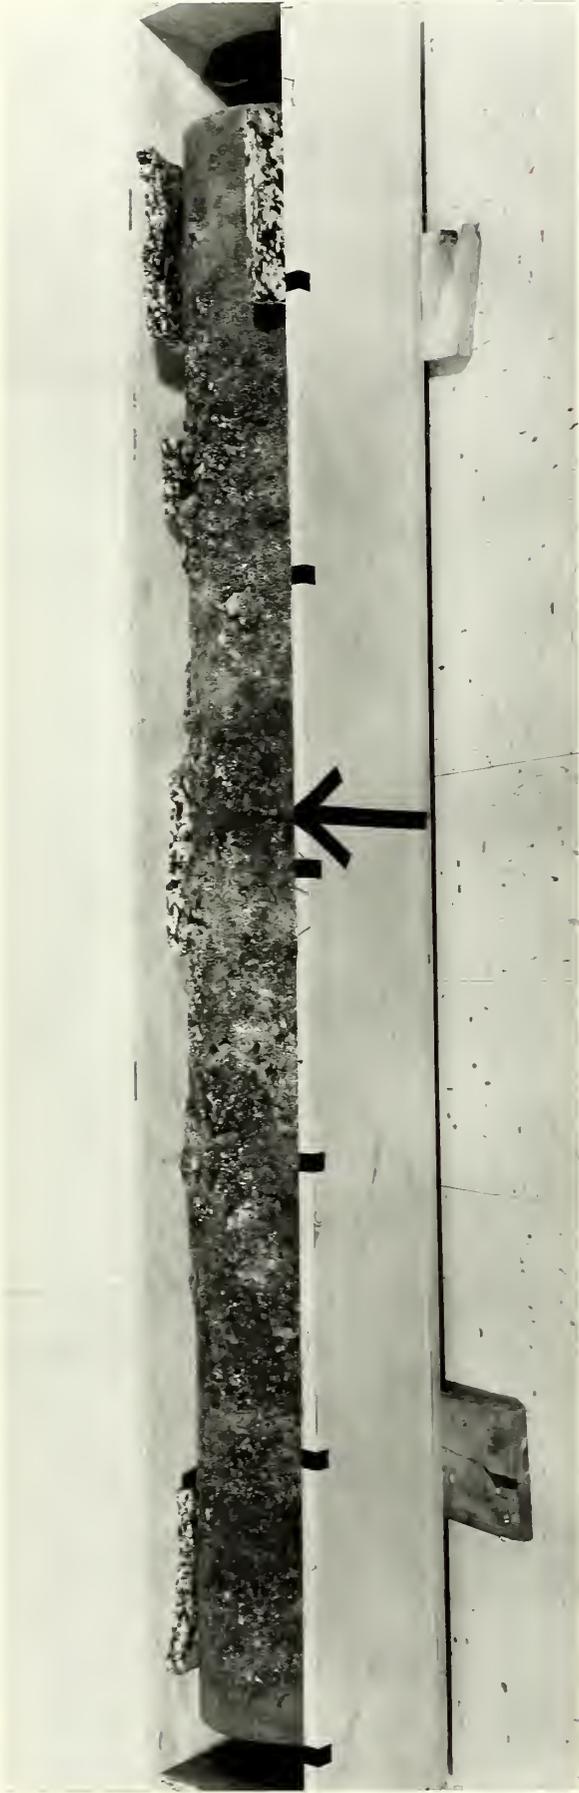
The submitted pipe length is shown as received at NBS in figure 1, except that the top of the wooden crate in which it was delivered had

Figure 1. Length of six inch diameter cast iron pipe natural gas main reported to be from Queens County, New York as received at NBS except that the top of the wooden shipping crate has been removed. The arrow near the center indicates the location of the crack. X 1/8

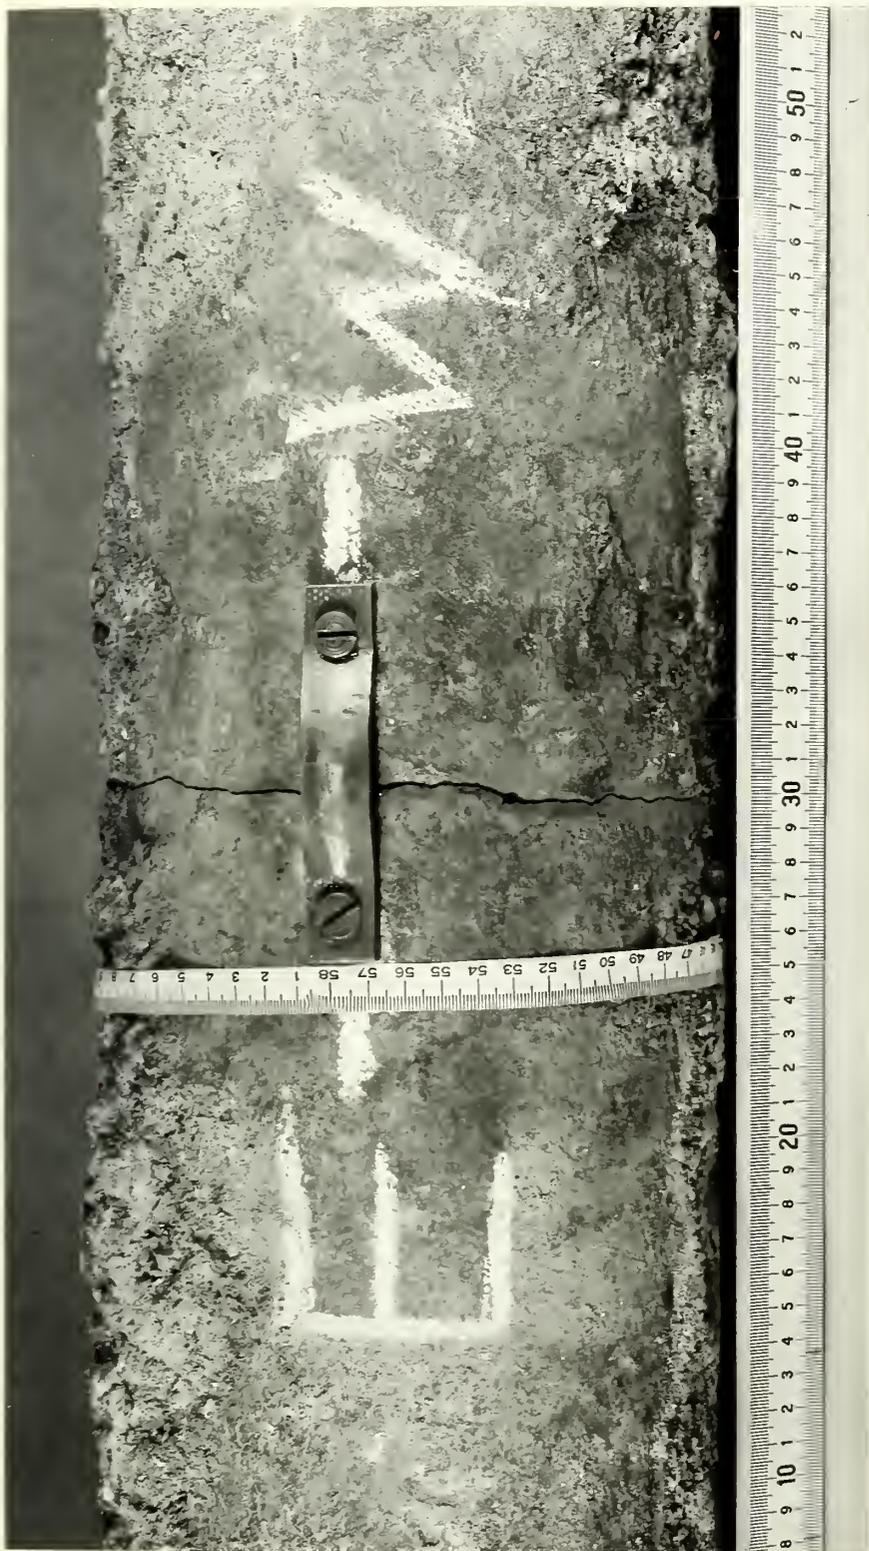
The transverse crack that can be seen in figure 2 had penetrated the entire wall thickness of the pipe around nearly 90% of the pipe circumference. With the pipe oriented as shown in figure 2, the "hinged" portion is near the bottom.

Figure 2. View of what was reported to be the top of the pipe as oriented in service. This photograph was taken after the pipe had been removed from the wooden shipping crate and steel straps had been placed across the crack. One of the steel straps can be seen in the figure. The "E" and "W" were written on the pipe with chalk before it was submitted to NBS.
X 1/2

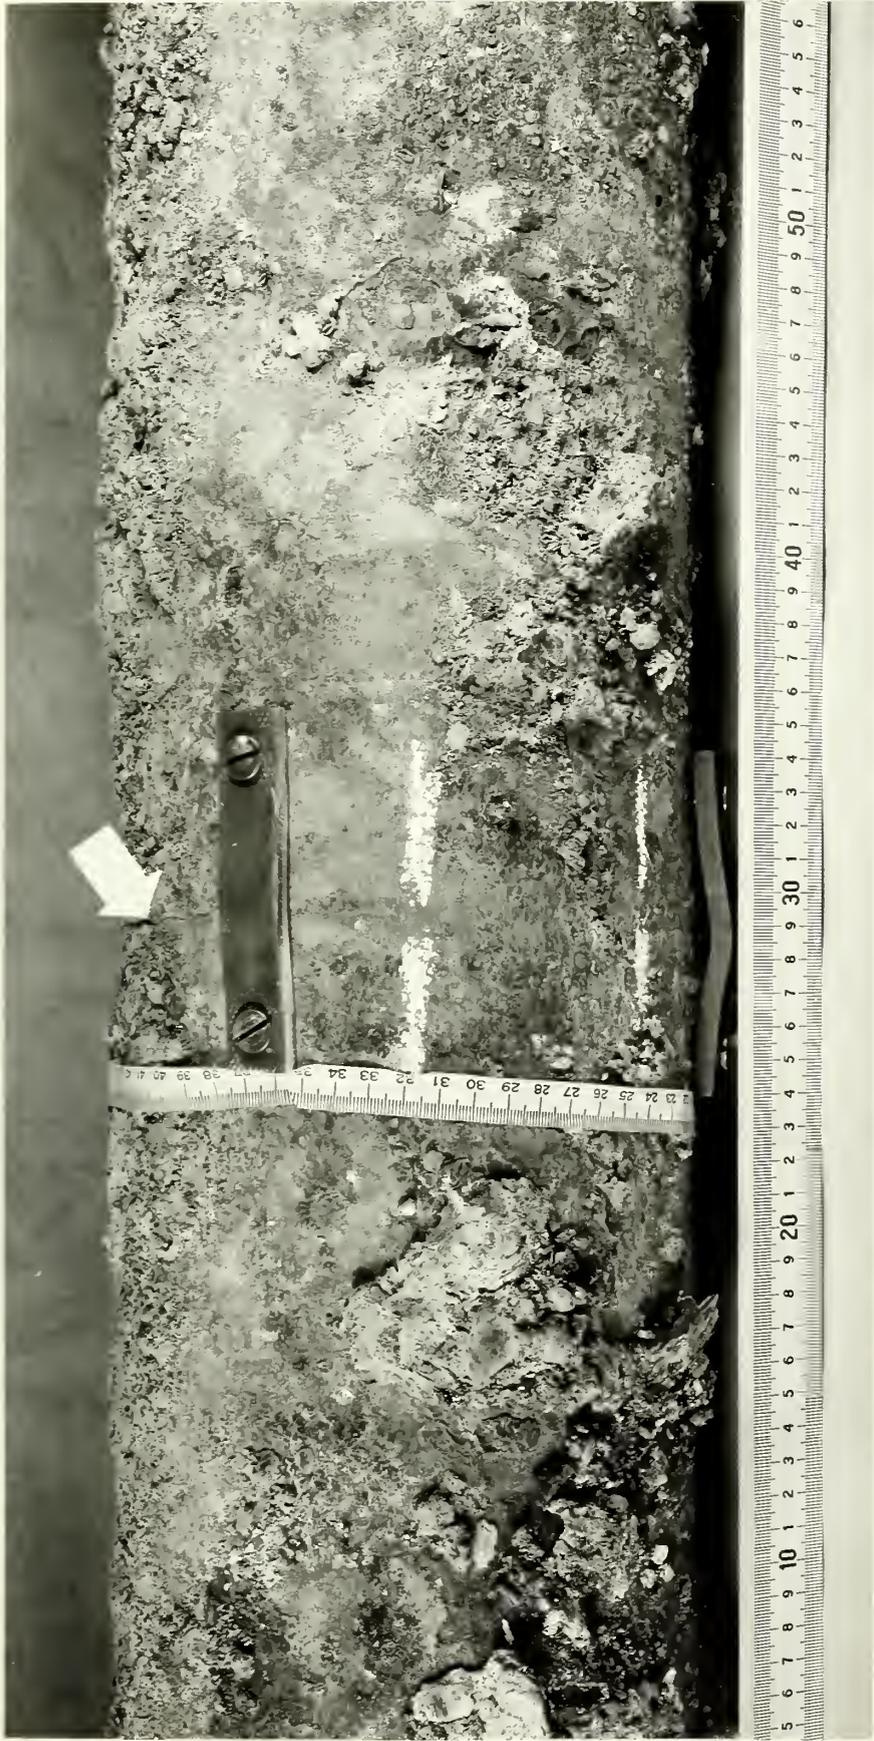
Figure 3. Bottom view of the pipe length in the vicinity of the crack (arrow). The two white, horizontal chalk marks indicate the approximate ends of the hinged portion. X 1/2

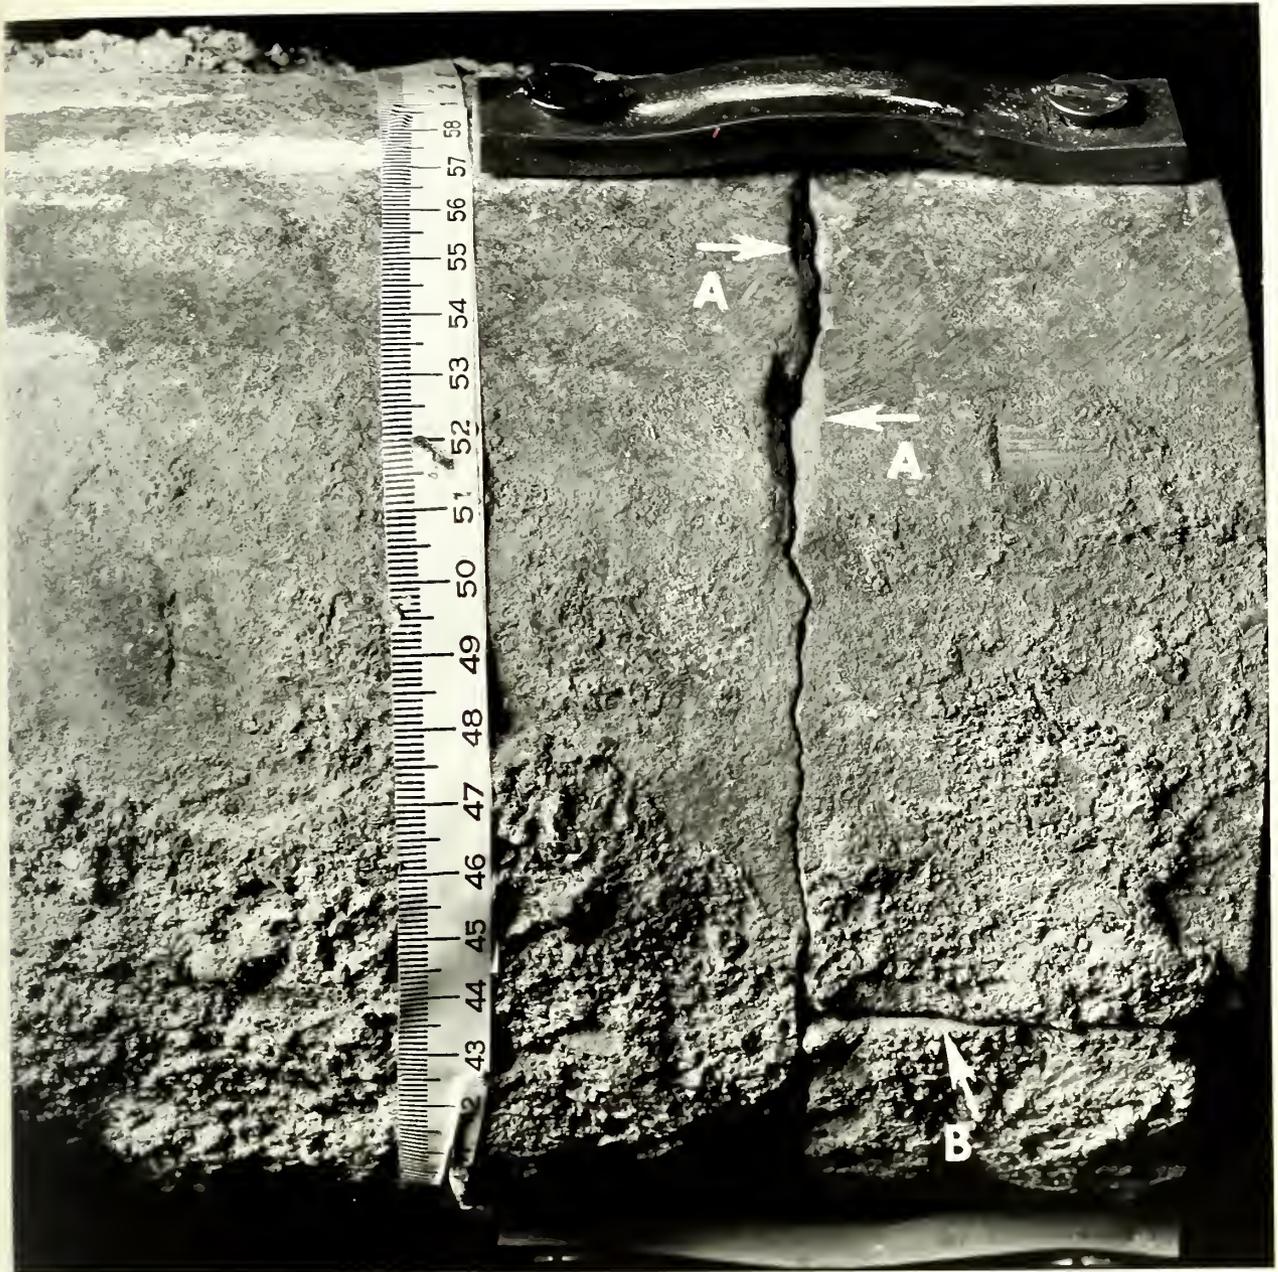
There were two depressions near the top of the pipe adjacent to the crack. It appeared as though material had either been chipped out or had fallen out. These depressions can be seen in figure 4. No other significant mechanical damage to the pipe was observed.

No significant mechanical damage to the pipe was observed, with the possible exception of two depressions adjacent to the crack near the top of the pipe where material appeared to be missing. A metallographic examination of a section through one of the depressions revealed graphitized material adjacent to the depressions. It is likely that the missing material was also graphitized. This graphitized region would have been rather easily knocked off during handling, which could explain the forming of the depression. A similar explanation might account for the second depression.

Figure 4. View of the pipe near the top showing depressions at the crack. The depressions are indicated by arrows "A." Arrow "B" indicates a sawcut made in the laboratory. This sawcut is not related to the failure. The W-length of the pipe is to the right of the crack and the E-length is to the left. X 1

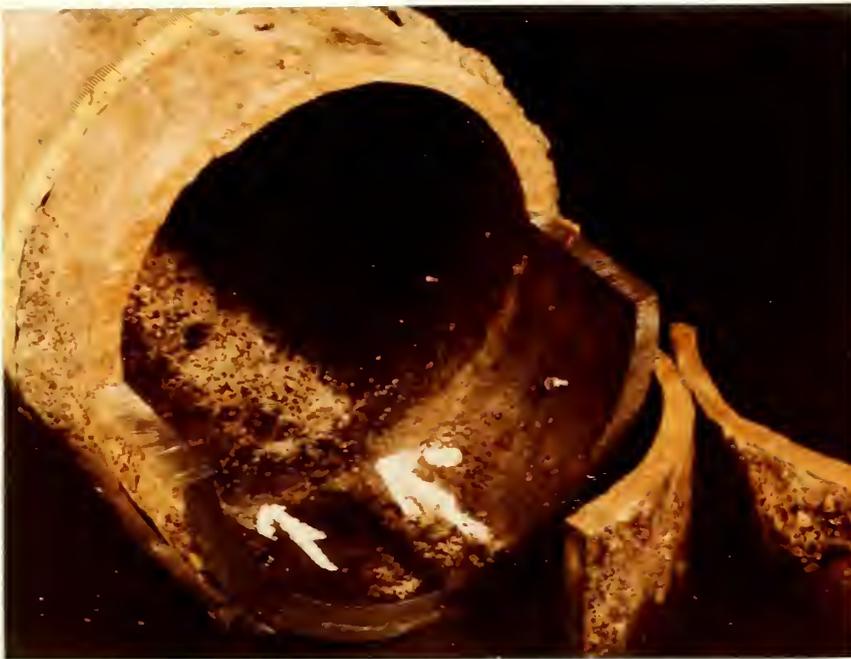
The entire exposed fracture surface was covered with what appeared to be a superficial, light reddish-orange corrosion product as shown in figure 5. Approximately one-half of the exposed W-length fracture surface was cleaned ultrasonically. The light colored corrosion product was removed by this cleaning operation. Beneath the light colored product, the entire portion of the fracture surface that had been cleaned was covered with a more adherent, darker colored corrosion product that was not removed by the ultrasonic cleaning. Much of this material was removed from approximately a 2 1/2 cm length of the fracture by repetitive replication with cellulose acetate, but some of it remained. This 2 1/2 cm length was about 180° circumferentially from the hinged portion and was in the vicinity of the probable fracture origin near the top of the pipe.

Perhaps the most significant feature of the fracture surfaces was the corrosion products found on them. The entire portions of the fracture surfaces that were exposed during the examination were covered with a light colored superficial corrosion product that was rather easily removed by ultrasonic cleaning. Beneath the light colored product, however, was a darker, more adherent corrosion product. Attempts to remove this darker material by ultrasonic cleaning were unsuccessful. Much of it was removed from a 2 1/2 cm length of the fracture by repetitive replication with cellulose acetate, but some remained. The amount, color, and adherence of the darker corrosion product on the fracture surface indicates that the crack was not "fresh."

Figure 5. Partially exposed fracture surfaces of the pipe showing corrosion product before any cleaning was done. The E-length fracture surface is intact and the W-length has been cut into two pieces. The white arrows indicate the approximate extremities of the crack. X 1/2

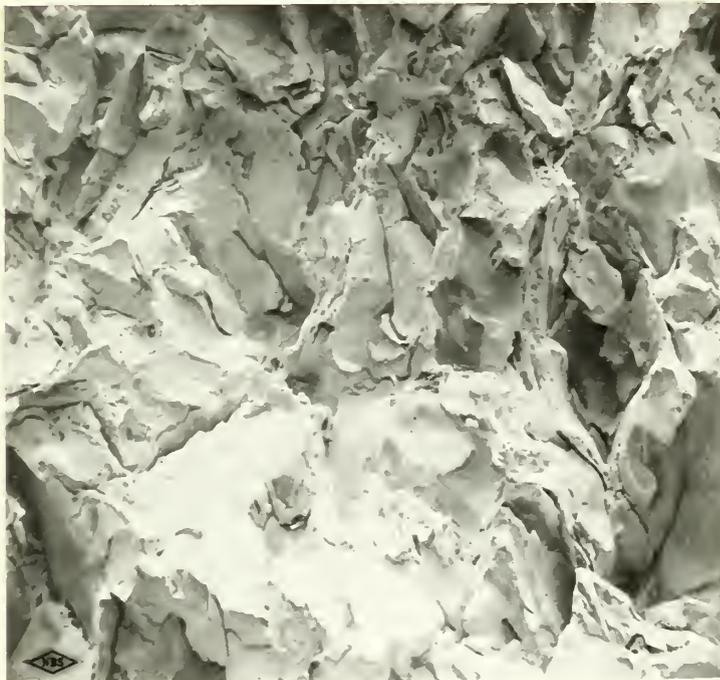
The 2 1/2 cm length of the W-length fracture that had been cleaned both ultrasonically and by repetitive replication was examined with the scanning electron microscope. Figure 6 shows features typical of those exhibited by the fracture about halfway between the inside and outside surfaces of the pipe. Two examples of the fracture surface features near the outside surface of the pipe are shown in figures 7 and 8. Note, the magnifications of figures 6, 7, and 8 are different.

Some evidence of cleavage appears in figures 6 and 7. The smooth appearing regions in figure 8 are cavities that may have been porosity or gas pockets. In figure 6, the narrow dark particles are graphite flakes. Such flakes are a normal constituent in gray cast iron. The graphite flakes are not as easily seen in figures 7 and 8. Fracture features near the inside surface of the pipe appeared similar to those shown in figure 8.

Figure 6. Scanning electron fractograph showing features typical for the region of the fracture about midway through the wall thickness. Cleavage is evident. X 110

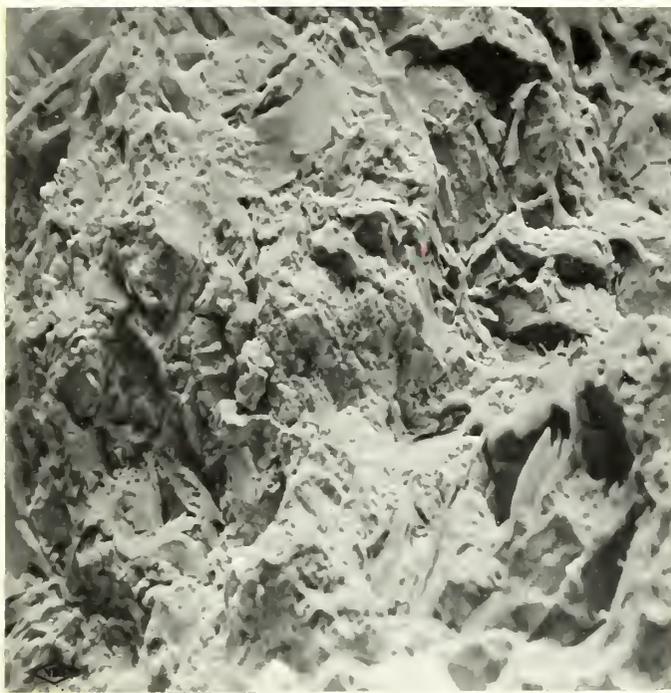
Figure 7. Scanning electron fractograph near the outside wall surface of the pipe. There is some evidence of cleavage. X 210

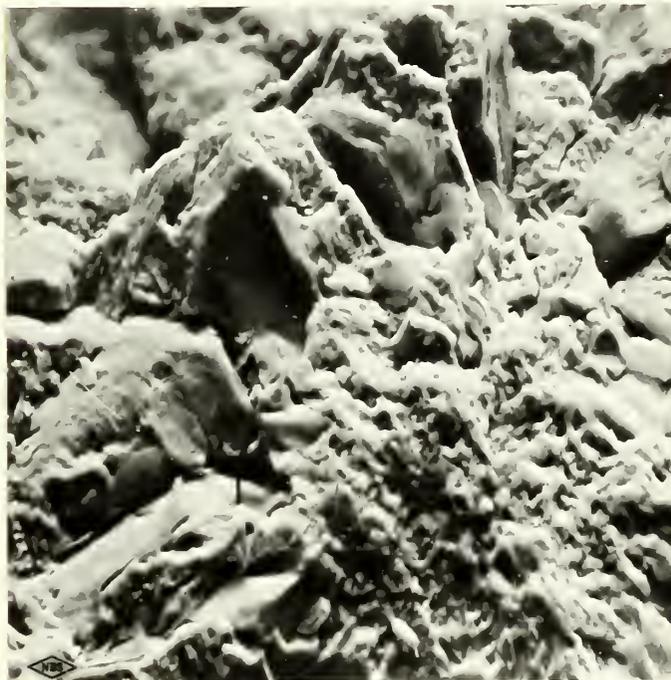
Figure 8. Scanning electron fractograph near the outside wall surface of the pipe. The smooth areas may have been regions of porosity or gas pockets. X 490

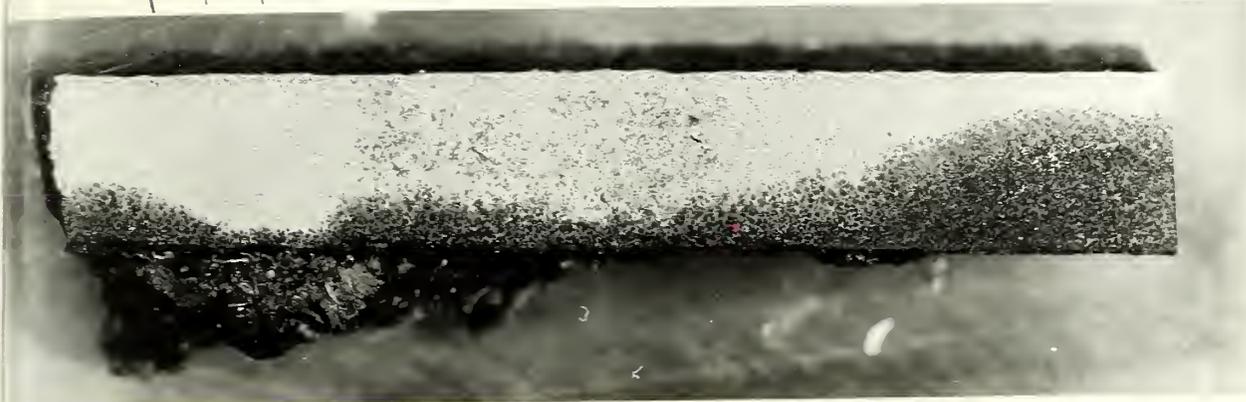
An unetched longitudinal section through the approximate top of the W-length of the pipe showing the fracture profile appears in figure 9. The fracture profile is at the left, the outside surface of the pipe is at the bottom, and the inside surface of the pipe is at the top as the section is oriented in the figure. Part of the fracture profile is shown at higher magnification in figure 10. The apparent lack of deformation adjacent to the fracture is characteristic of a low ductility or brittle fracture. The thin dark particles appearing in figure 10 and in several subsequent figures are graphite flakes.

The mottled region that can be seen in figure 9 in about the center one-third of the section length, and away from the outside wall surface of the pipe, is in an area of porosity or gas pockets. Some of this porosity is shown at higher magnification in figure 11. Of the sections of the pipe examined, the area shown in figures 9 and 11 contains the greatest concentration of porosity.

The dark region along the outer wall surface in figure 9 is graphitized. Two areas from the section appearing in figure 9 showing partial graphitization and nearly complete graphitization appear in figures 12 and 13, respectively.

The region of severest graphitization in the sections examined can be seen in figure 9 near the right side of the photomicrograph. Graphitization has penetrated about 3/4 of the wall thickness of the pipe in this region.

Figure 9. Etched longitudinal section intersecting the W-length fracture at a point 5 cm beyond the 9 cm point on the circumferential metric scale that can be seen in figure 2. The fracture is vertical at the left. The outside surface of the pipe is at the bottom, and the inside of the pipe is at the top. Some adherent soil and ash appear on the outside surface. Etchant: 1% nital X 2 1/2

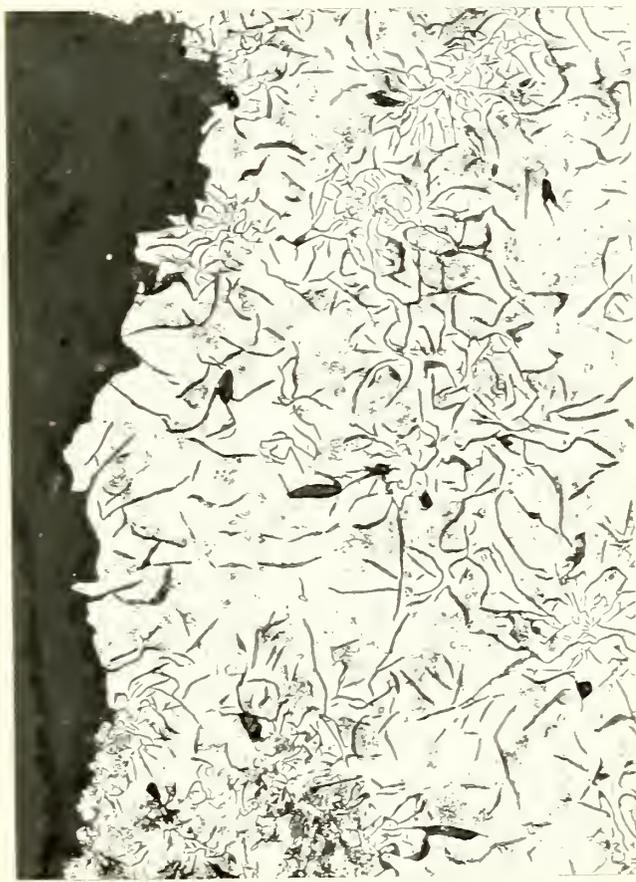
Figure 10. Part of the longitudinal section shown in figure 9 in the unetched condition. The fracture profile is at the left. There is no evidence of deformation. As-polished X 100

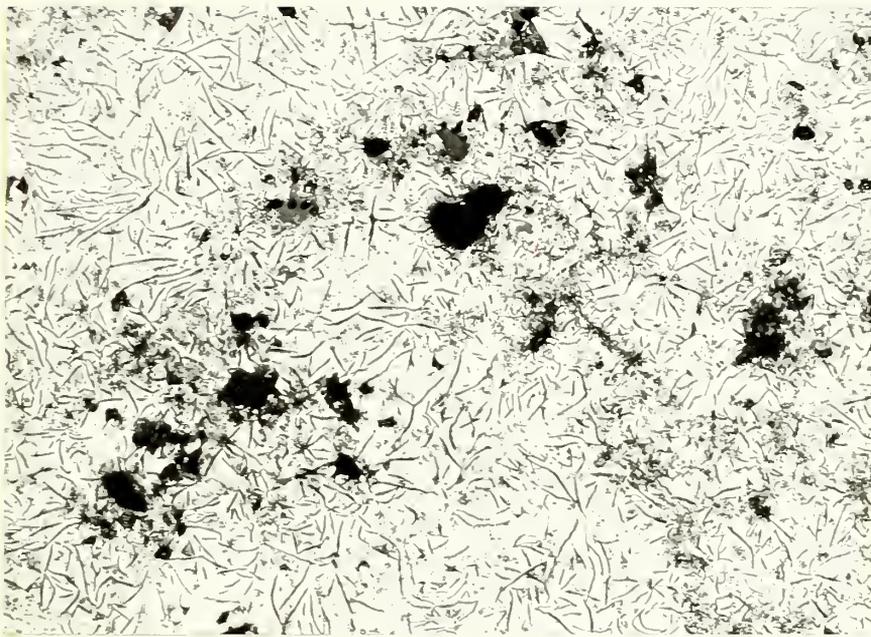
Figure 11. Center area of the section shown in figure 9 where there is a concentration of porosity or gas pockets.
As-polished X 50

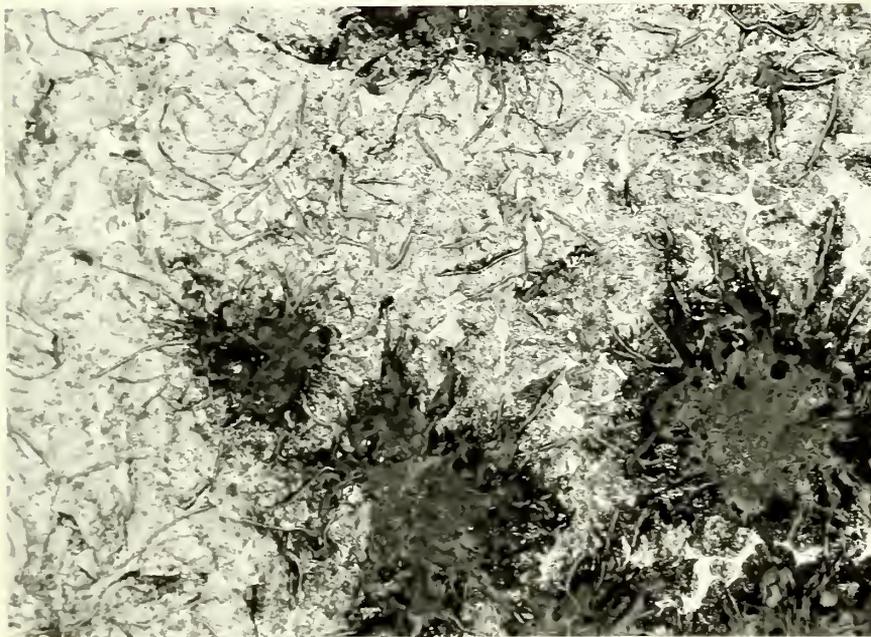
Figure 12. An area from the section shown in figure 9 where there is partial graphitization.
Etchant: 1% nital X 200

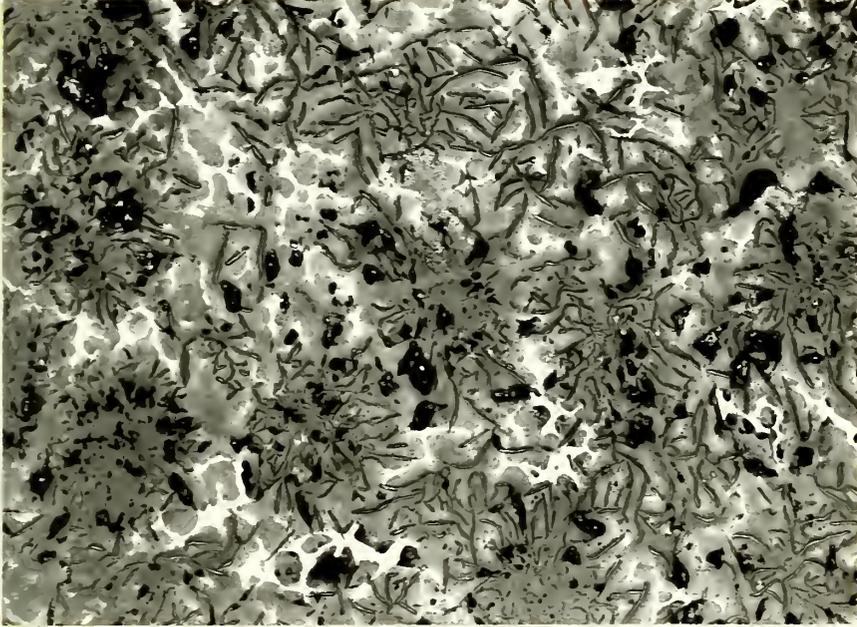
Figure 13. An area from the section shown in figure 9 where graphitization is nearly complete.
As-polished X 100

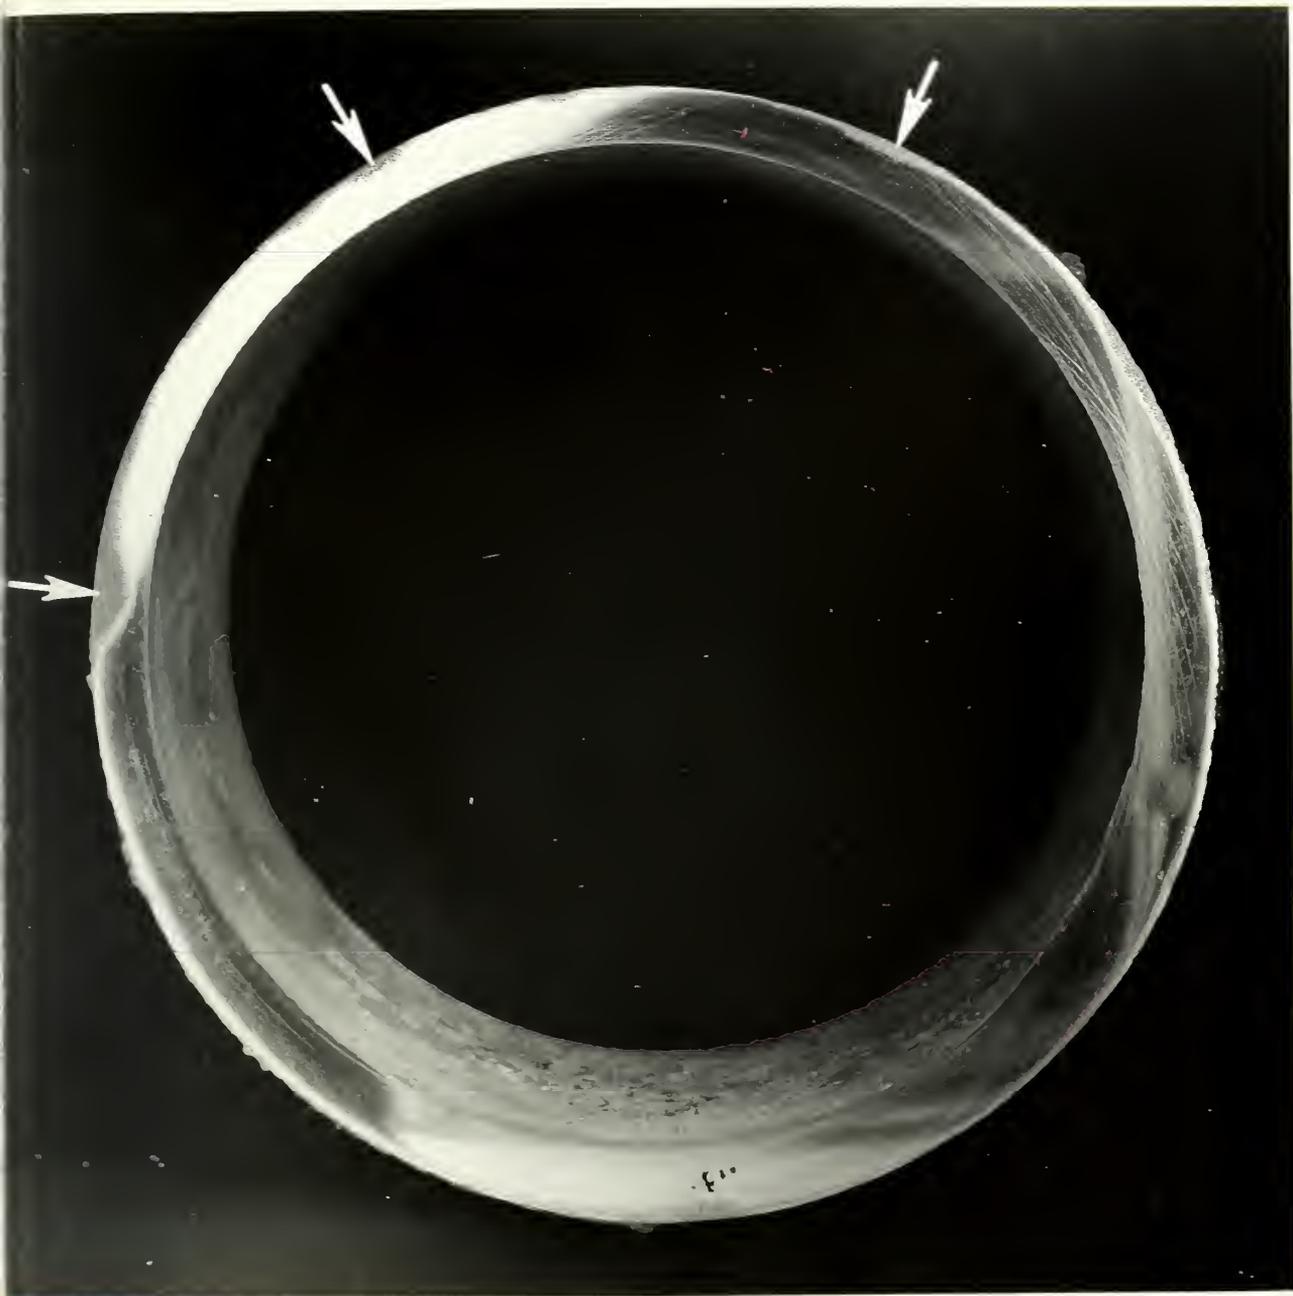
Two transverse rings were taken through the W-length of pipe at 6 cm and 15 cm from the fracture. Both of these rings exhibited some evidence of graphitization. One of the rings is shown in figure 14.

Graphitization was discontinuous around the two complete circumferential sections examined. Graphitized regions penetrated the wall from the outside to depths ranging from essentially zero to 75% of the wall thickness. Because there is less resistance to crack formation in graphitized regions, as compared to non-graphitized regions, the presence of graphitization probably assisted in the development of the crack. However, the discontinuous nature of graphitization around the circumference suggests that graphitization did not play a significant role in the propagation of the crack.

Figure 14. Transverse section through the W-length of the pipe about 6 cm from the fracture exhibiting some graphitization adjacent to the outside wall surface. Arrows indicate some of the regions of graphitization.
As-polished

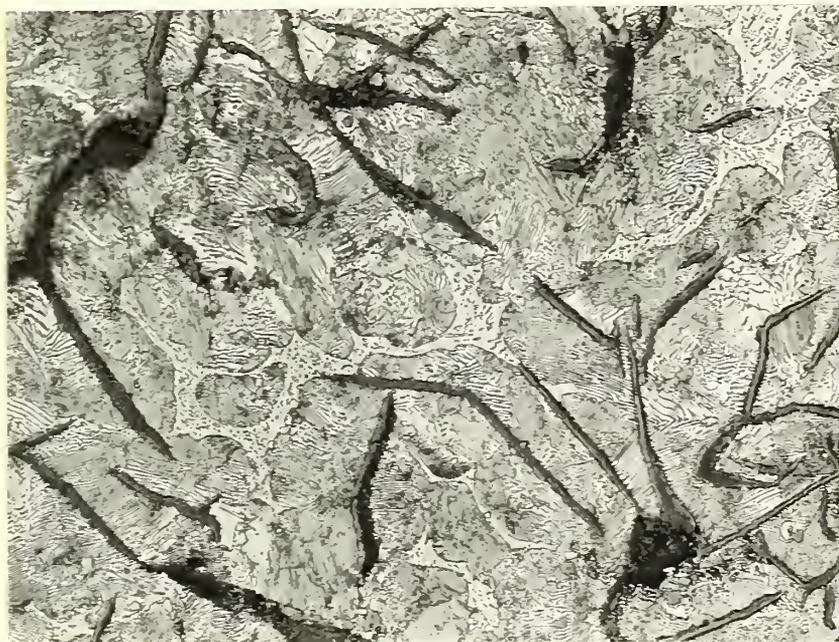
The typical microstructure of the pipe material away from the graphitized regions is shown in figure 16. The microstructure consists primarily of graphite flakes (long, thin, dark particles) and pearlite (fingerprint pattern) with small amounts of ferrite (light color) and steadite (small rounded particles).

Except for the regions of porosity and graphitization, the microstructure of the pipe material appeared to be as expected for gray cast iron. The microstructure consisted primarily of graphite flakes and pearlite with some ferrite and steadite. The amount of steadite does not appear to be excessive.

Figure 16. Typical microstructure of the submitted pipe material in an area away from graphitization and porosity. The microstructure consists primarily of graphite flakes (long, thin, dark particles) and pearlite (fingerprint pattern) with small amounts of ferrite (light color) and steadite (small rounded particles).
Etchant: 1% nital X 400
